ROB OPERATION BEYOND NORMAL CONDITIONS

CMS Week June 2002

ROB STATUS

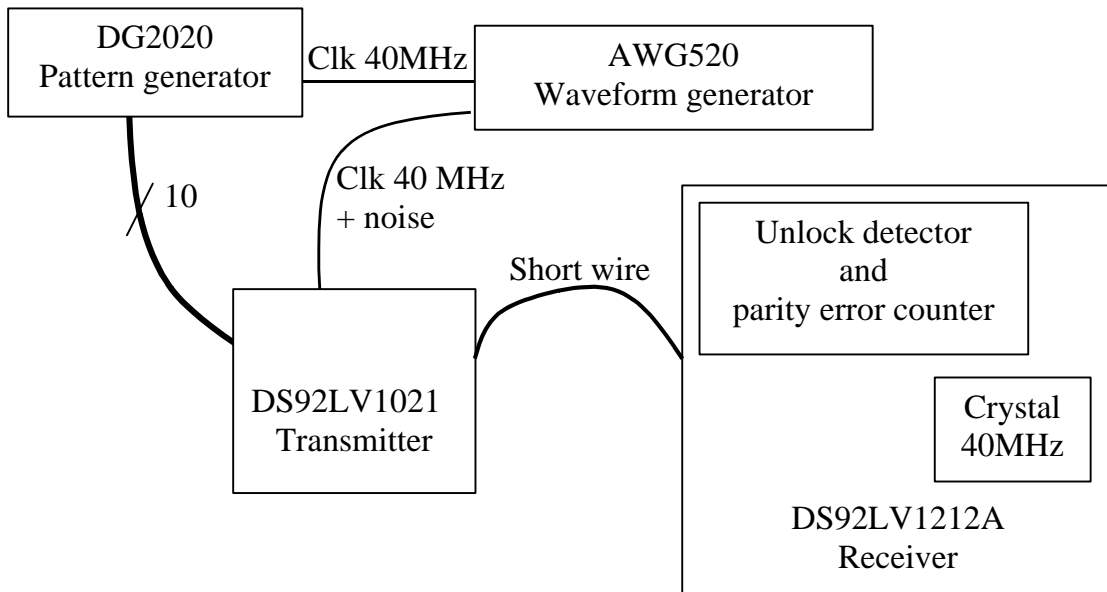
Operation at 40 MHz \Rightarrow 480 Mb/s

Max. jitter	Rms	Failure rate
± 600 ps	130 ps	$< 5 \cdot 10^{-13}$
± 800 ps	170 ps	$= 5 \cdot 10^{-12}$
± 900 ps	190 ps	$= 10^{-9}$

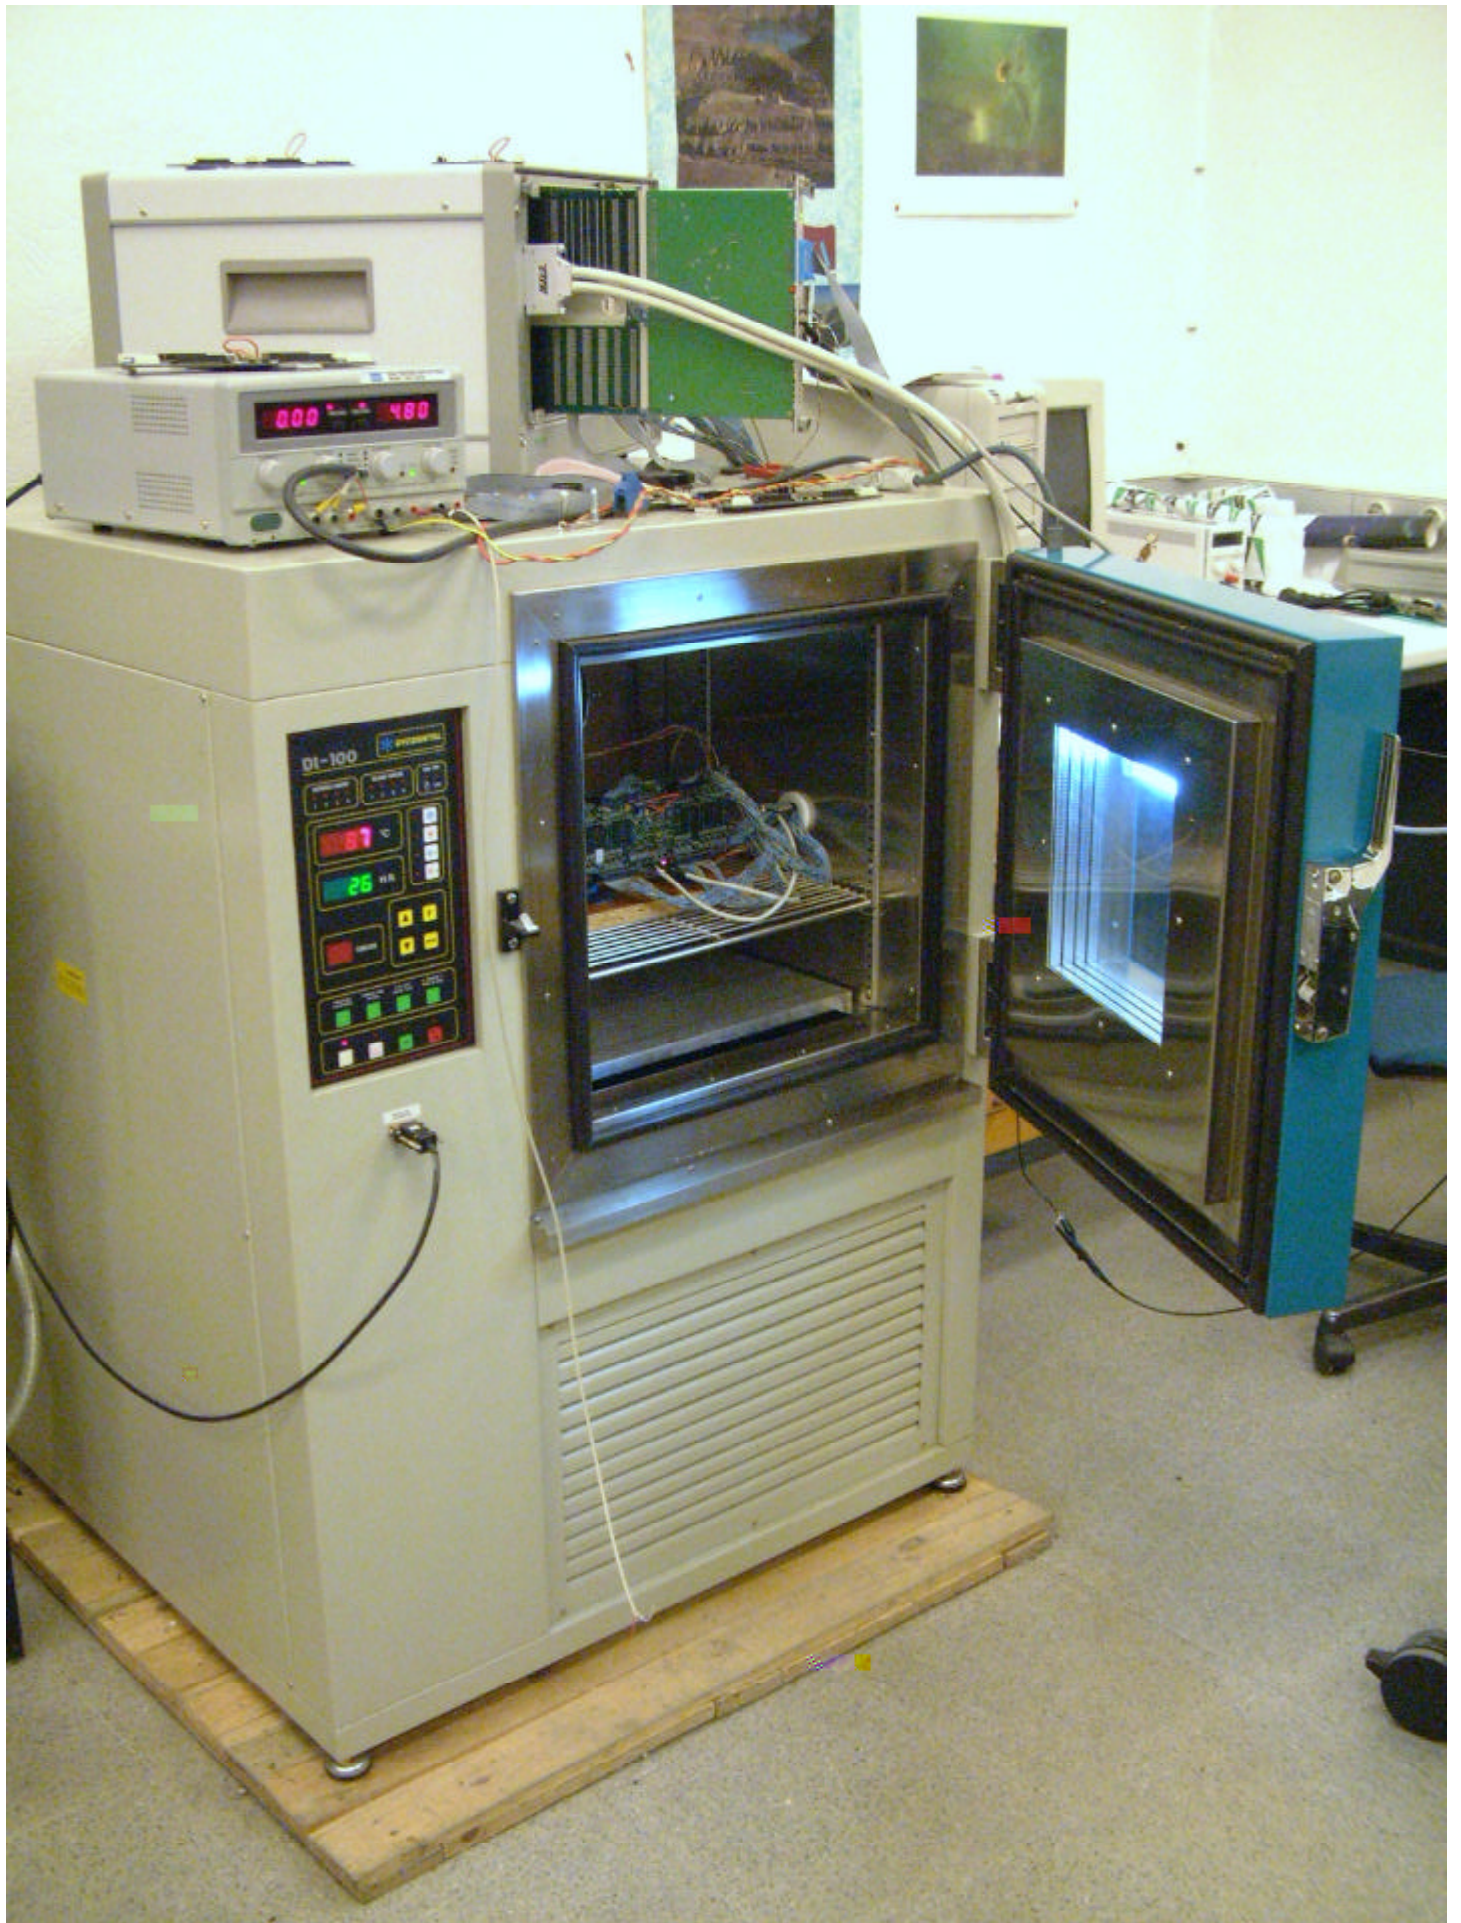
Environmental chamber

ROB can be fully operated and monitored.

➤ Soft temperature cycling

- Within every component safety margin: 0° to 70°
- Not to exceed device specs just to find any variation due to temperature

➤ Life time test of one board at a time at 105°C

- Find out failure mechanisms with an accelerated stress test
- May give us an idea of the most probable failure modes
- At the moment: 400 hours and all devices are working properly.

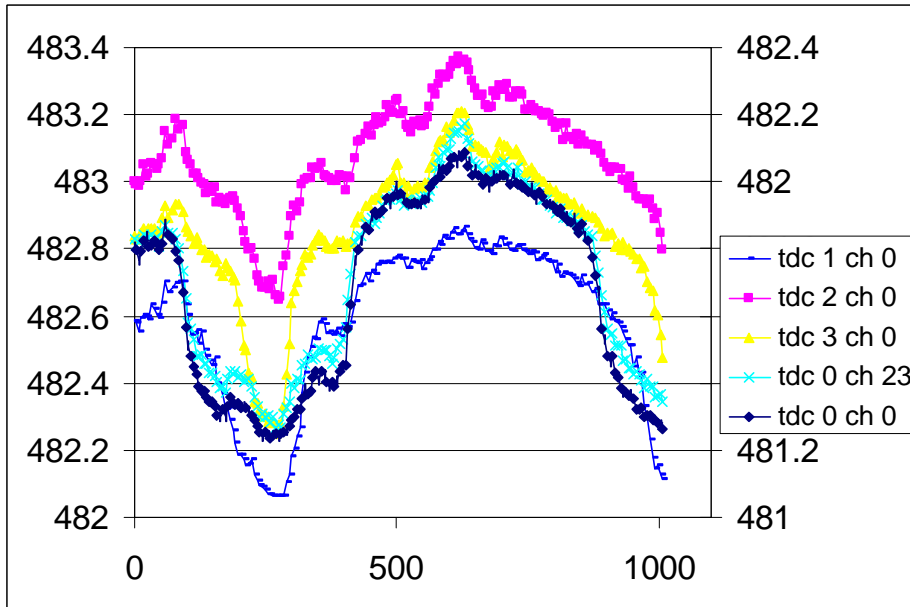
- Time measurement variations:
 max 1 ns from 0°C to 70°C
 max slope ~ 45ps/°C
 Slope at 25°C ~ 10ps/°C
- Higher temperature - faster signals
- Slightly different behaviour depending on each TDC

- All devices bear perfectly temperature conditions.
- Small time shift: **900 ps/70°C**. Max. Variation **~40ps/°C**.

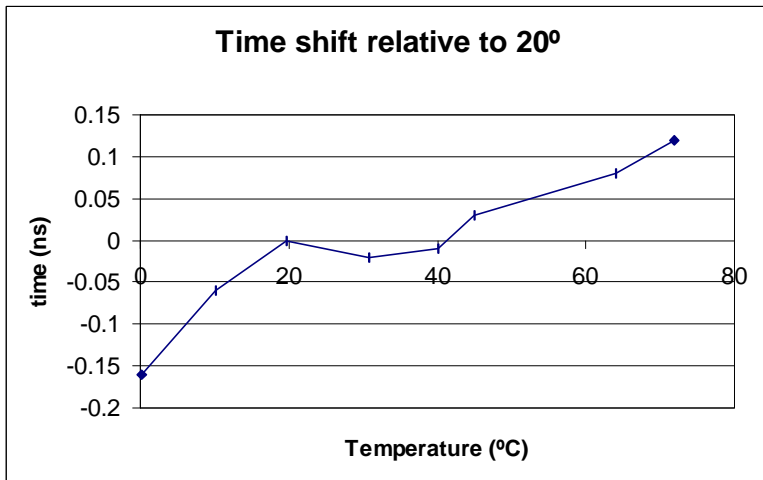
~30% of the time shift is due to DS90LV048A differential line receivers
